## **My experiences with Sunbeam S8.**

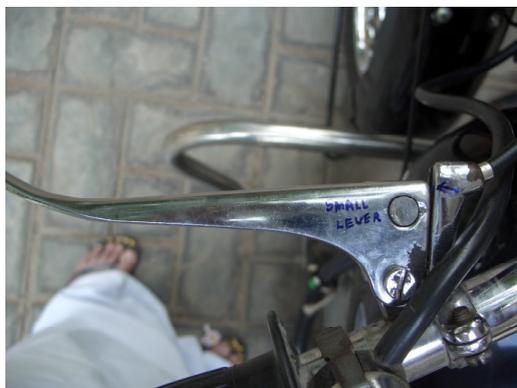
After completing assembly of the machine, I found by chance, the reason for the abnormal behavior of the clutch. I found that, the clutch lever as fitted to the machine was not an original part for this Sunbeam. The distance between the fulcrum and the hitching point of the Bowden wire were different between the front brake lever and the clutch lever. You may observe this in the pictures below.

Incorrect lever fitted originally when the machine was received.

With the lever replaced with a correct part, the clutch problem was resolved. This and similar problems are uncommon but if ever it happens it is also difficult to locate the problem.

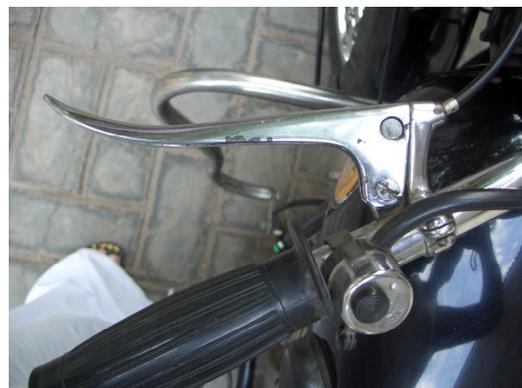
Correct clutch lever that I replaced the original with.

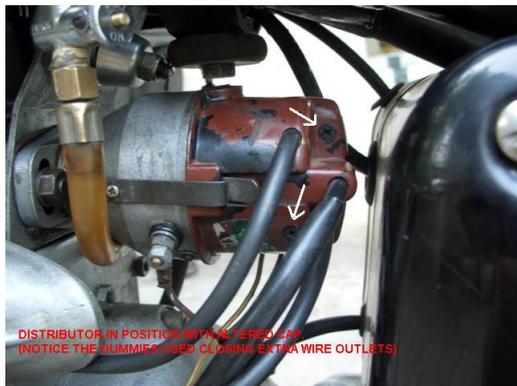
Distributor in position with altered cap.  
(Notice the dummies used closing extra wire outlets)

I could locate a Lucas distributor cap of a four-cylinder car engine readily available in the market. The cap-locating peg on distributor body and two of the plug wire take off positions were matching with that of the original cap and so I decided to make use of this cap. I faced another minor problem here. The car distributor cap was higher than the original one and the distributor rotor wasn't touching the carbon inside the centre of the cap. The high voltage from the coil passes to the plug wires through this carbon only. Fortunately, there was enough material on the bottom side of the car distributor cap that I could turn it down and reduce the height.

This alteration perfectly rectified the ignition problems. Later on, I installed a Rooster booster to improve the performance further and I found tremendous improvement on installation. The guidance provided by Martin Vincent of (Rooster Booster) "[info@roosterignitions.com](mailto:info@roosterignitions.com)" was of immense help to me. Later on I purchased an "Ignition Coil 6 Volt Dual Output" from [ignition@pazon.com](mailto:ignition@pazon.com) to have a ready alternative and this made the ignition circuit perfect and foolproof. I could use the distributor cap or dual output coil. The system with distributor cap looks more original and with dual output coil, it was more reliable. In either cases I made use of the Rooster booster as it improves performance in both cases.

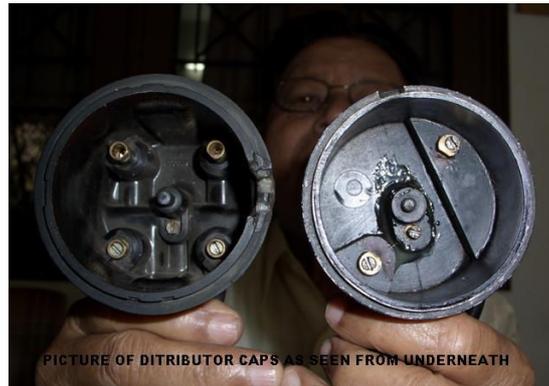
Picture of distributor caps as seen from underneath

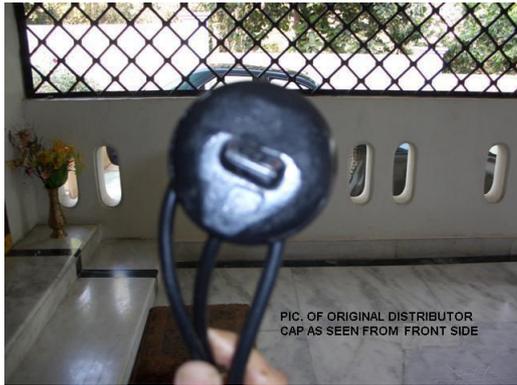
Picture of original distributor cap as seen from top side

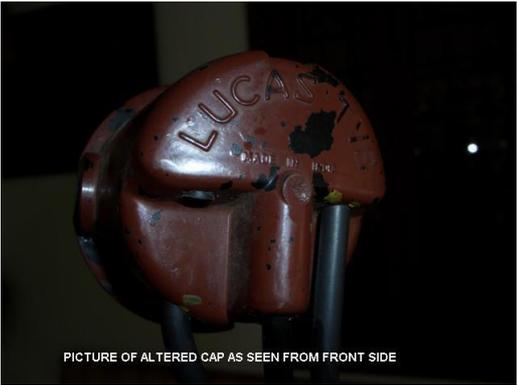
Picture of altered cap as seen from top side

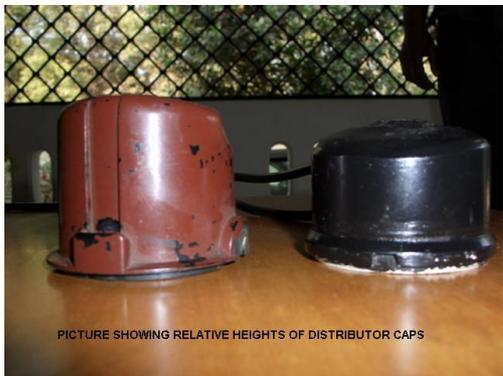
Picture showing relative heights of distributor caps

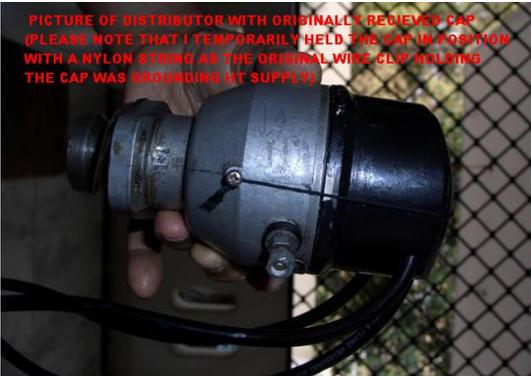
The next problem I faced was with ignition circuit. When the machine was delivered, it was not fitted with an original distributor cap. It had a hand made distributor cap and not of a good quality. In moist weather, I noticed high voltage passing from coil to plug wires through the distributor rotor was arcing between the distributor cap and wire clip holding the cap, as the wire clip is grounded through the distributor body and consequently the engine was missing. This used to become worse during rain. I provided insulation between the cap and the clip. This has reduced the problem but not cured it.

Picture of distributor with originally received cap. (Please note that I temporarily held the cap in position with a nylon string as the original wire clip holding the cap was grounding HT supply

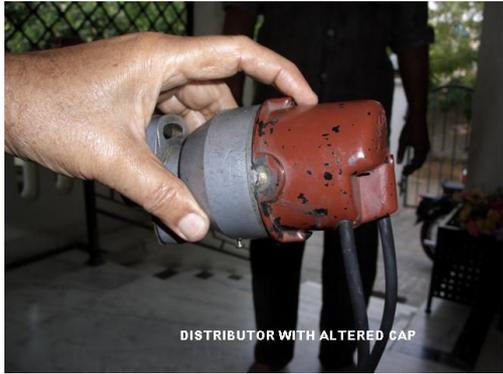
Distributor with altered cap

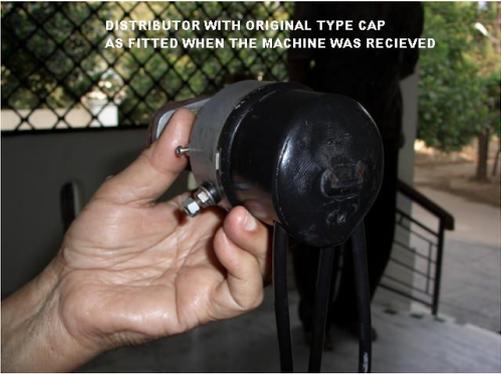
Distributor with original type cap as fitted when the machine was received

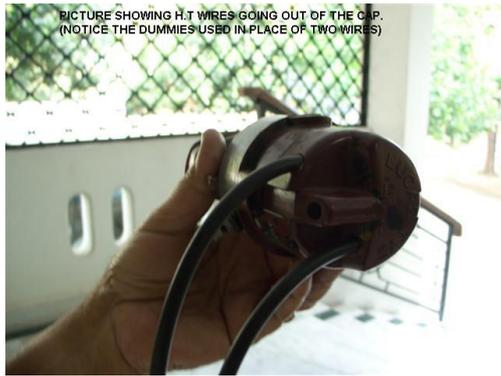
Notice the dummies used in place of two wires
