## My Sunbeam Mechanical Experiences-Part II - By Y. Janardhana Rao

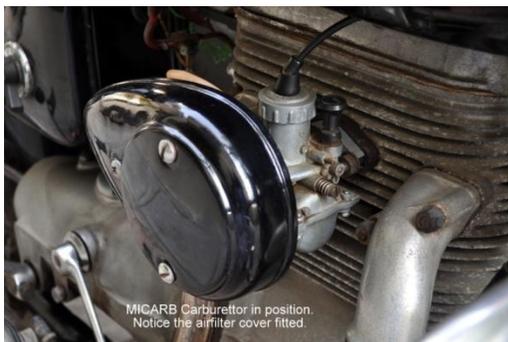
Look how original the assembly looks

Next problem was with the carburettor. The original Amal carburettor is worn and was giving me problems while tuning up. In spite of very careful tuning the machine was running rough. The machine needed frequent tuning up to keep it fit. When I searched in the local market (I live in India) for an Amal carburettor and / or spares in the local market, the salesman suggested that I go for a MICARB, a copy of Mikuni carburettor, made in India. This directly fits as the flange size is similar to that of original Amal carburettor. By making a small adaptor, original air filter and air filter cover also could be fitted. This looks absolutely original. On fitting this carburettor, the performance has vastly improved; the machine is giving better mileage. Quicker starting and there is no need for frequent tuning. The machine ticks over nicely. Please visit [http://www.hitchcocksmotorcycles.com/pictures/content2/micarb\\_notes\\_-\\_a4.pdf](http://www.hitchcocksmotorcycles.com/pictures/content2/micarb_notes_-_a4.pdf) for a write-up on the Micarb carburettor. I had paid Indian Rupees 900/- for this MICARB carburettor which amounts to less than 9 GBP at the present rate of conversion.

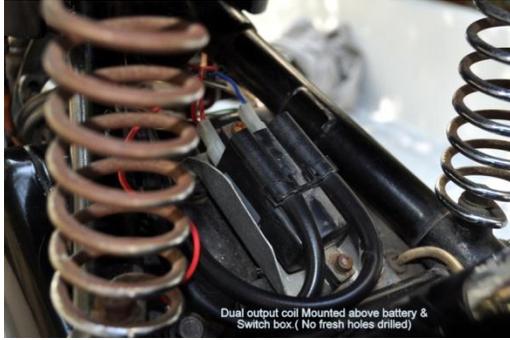
Ignition coil with heat sink

The distributor cap was giving me problems. Particularly in rainy season and in moist weather, the HT spark was arcing between metallic objects such as the cap clip holding the distributor cap etc. The distributor cap was a copy of the original cap and made of substandard material. This problem I over came initially by fitting a genuine Lucas cap of a four cylinder car. This was explained in greater detail in my article 'My Sunbeam Mechanical Experiences' in classicglory.com. To further improve this aspect and to avoid complications arising out of the old and worn distributor, I had fitted a Pazon code (IC03) 6V dual output Ignition coil. (Picture showing the location of dual output coil attached) For those who have an access to old car and motor cycle parts, a 6 V dual output coil may be available much cheaper as they were fitted on many Japanese motor cycles and older Citroen cars etc. This dual output coil could be mounted above the battery and control boxes under the seat. No additional drilling of holes is required. In this position the chances of the ignition coil overheating are very remote. The system is also called wasted spark system. This Pazon coil cost me NZ\$ 90.64.

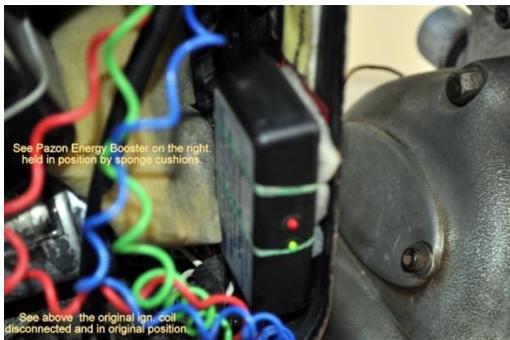
See the small LEDs of Booster. They help to locate TDC also easily.

To further improve the efficiency of ignition system I had fitted a Pazon (code PIEBP) --- Energy Booster II, Positive Earth- Installation of this booster is very simple as it is supplied with all the necessary wires and clips etc. This can be fitted inside the box on which the ammeter and ign. switch are mounted. There is ample space here to accommodate the booster. Fitment of the booster needs disconnection or removal of the condenser. So by eliminating the condenser we are eliminating another trouble giving component. Original 6V ign. coil is left at its original place and in case one wants to revert back to original set up it can be done in a few minutes.

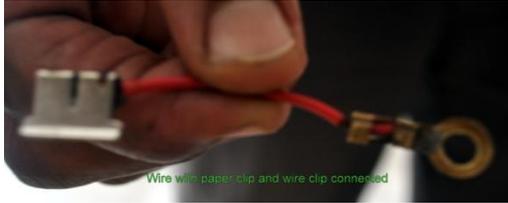
The Jumper Wire

If one observes the routing of supply to the contact breaker points it could be seen that there is a vulnerable point for loose contact at the junction where the bracket from distributor terminal meets the CB point spring. Sometimes loose contact was developing at this joint and I over came the problem by running an additional jumper wire bypassing this vulnerable point to eliminate the risk of a loose contact. (See the following picture)

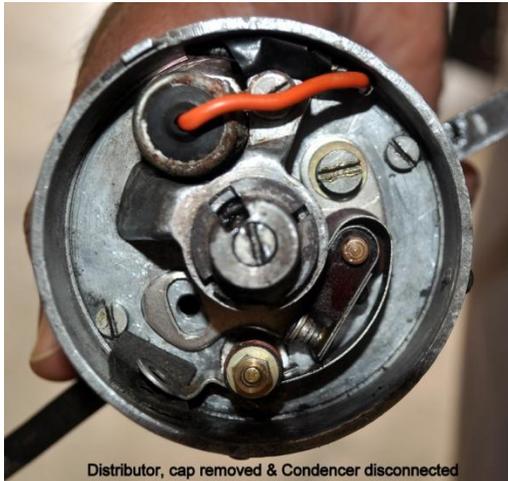
Condenser disconnected but left in place  
In case one wants to revert to originals.

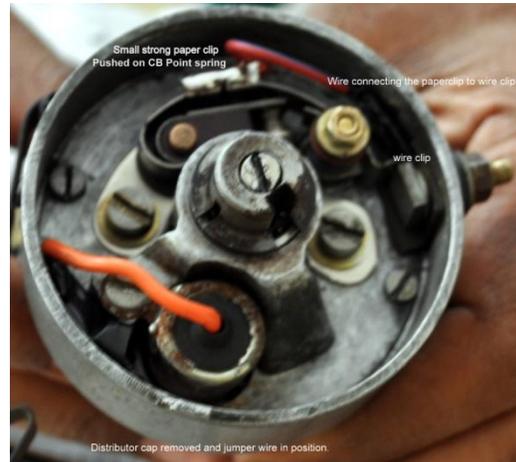
Distributor with jumper connected.

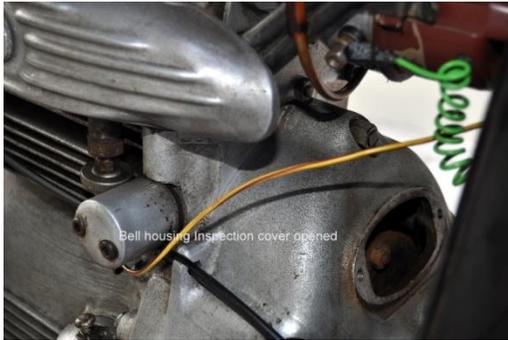
Bell housing- Inspection door removed

- 1) Remove the oval inspection door on the upper side of bell housing.
- 2) Make a 'T' shaped pointer, as shown in the picture in thin sheet metal so that it could be fixed on the inspection cover holding bolts. (Picture enclosed)
- 3) The downward protruding arm of this T could be cut like an arrow.
- 4) When this pointer is fixed in position, the arrow will be closer to the nut on which a blob of white paint is put or castle or domed nut as suggested by me.
- 5) This enables setting correct timing. The centrifugal timing advance can also be checked by using timing light.

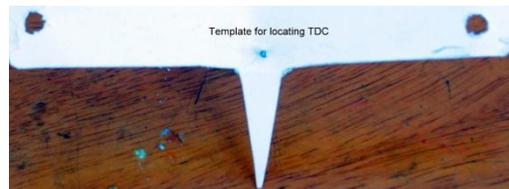
Template of pointer

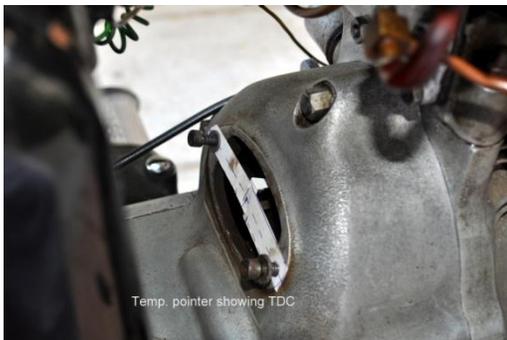
Pointer in position.
